Four Firefighters Injured In Lithium-Ion Battery Energy Storage System Explosion - Arizona

Mark B. McKinnon
Sean DeCrane
Stephen Kerber

UL Firefighter Safety Research Institute
Columbia, MD 20145

July 28, 2020

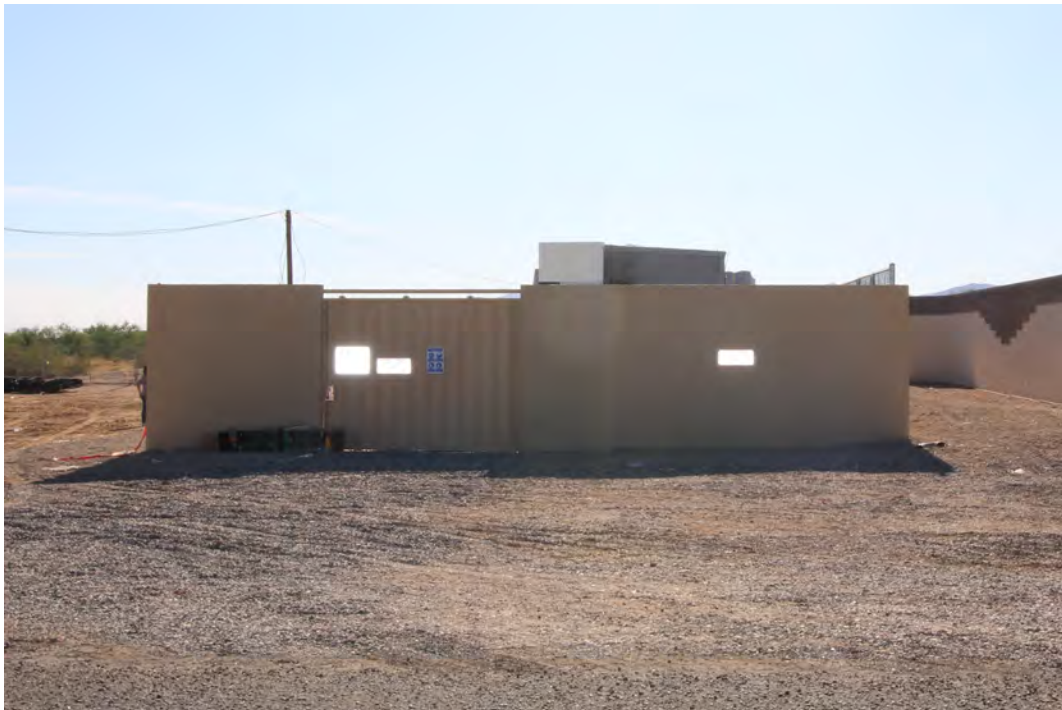
Figure 4.2: Photograph of the solid wall and gate to the northeast of the ESS [13].

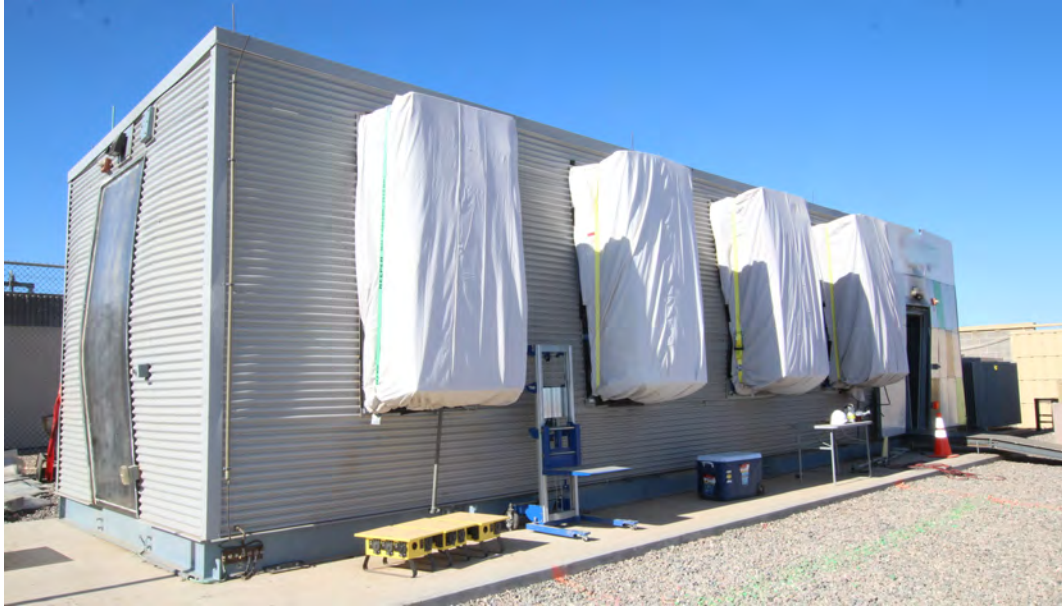
Figure 4.3: Photograph of the ESS after the incident from the southeast [13].

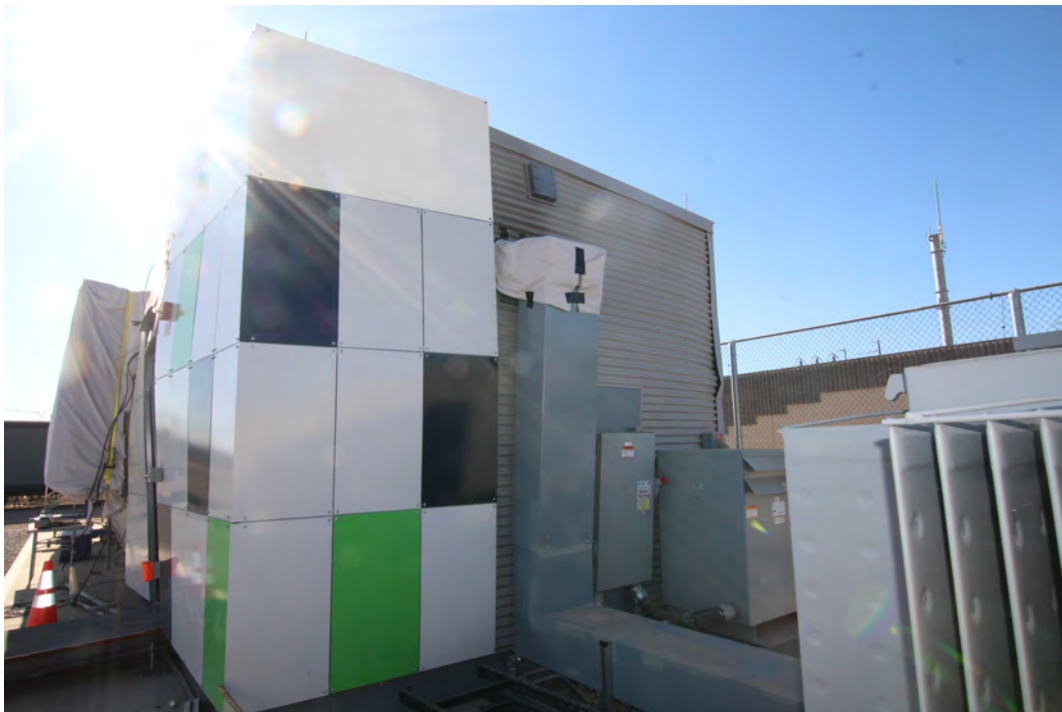
Figure 4.4: Photograph of the ESS after the incident from the northeast [13].

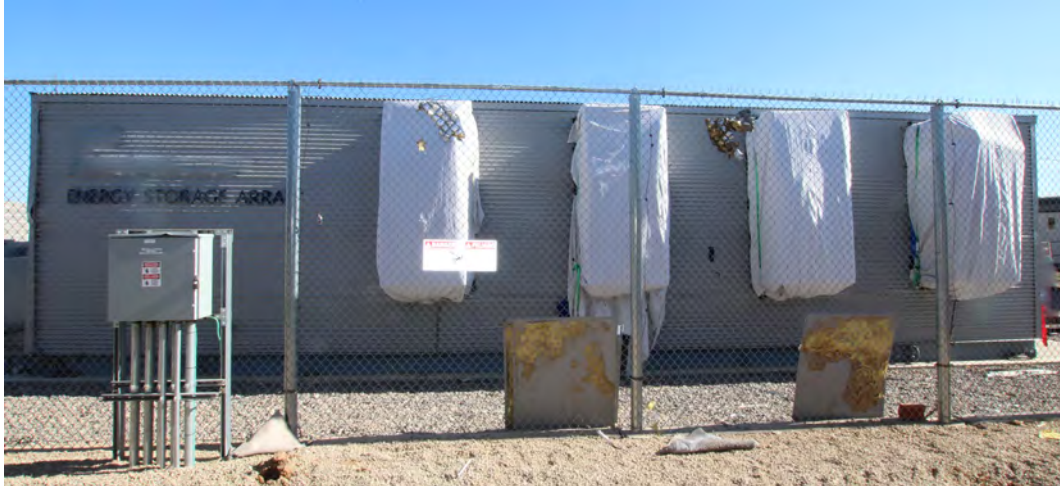
Figure 4.5: Photograph of the ESS after the incident from the northwest [13].

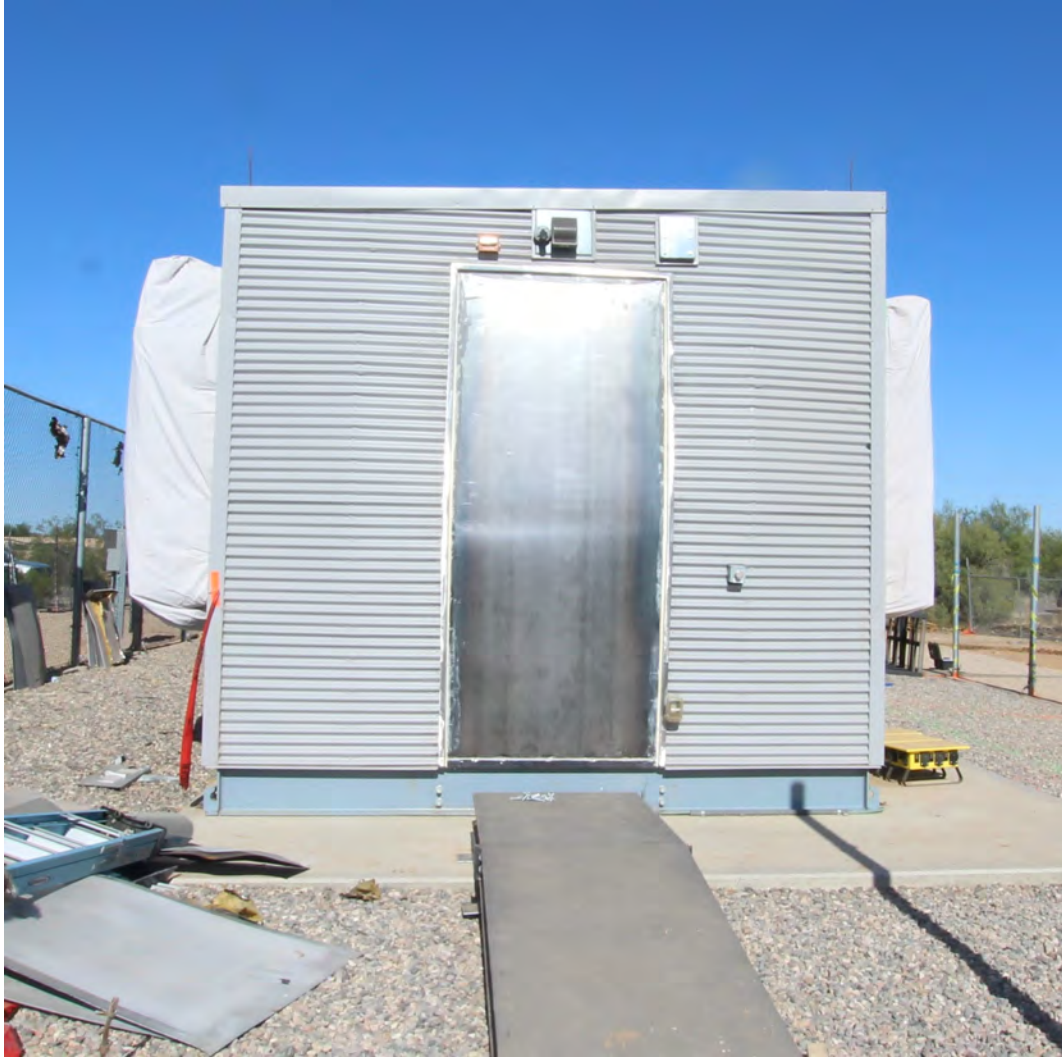
Figure 4.6: Photograph of the ESS after the incident from the southwest [13].

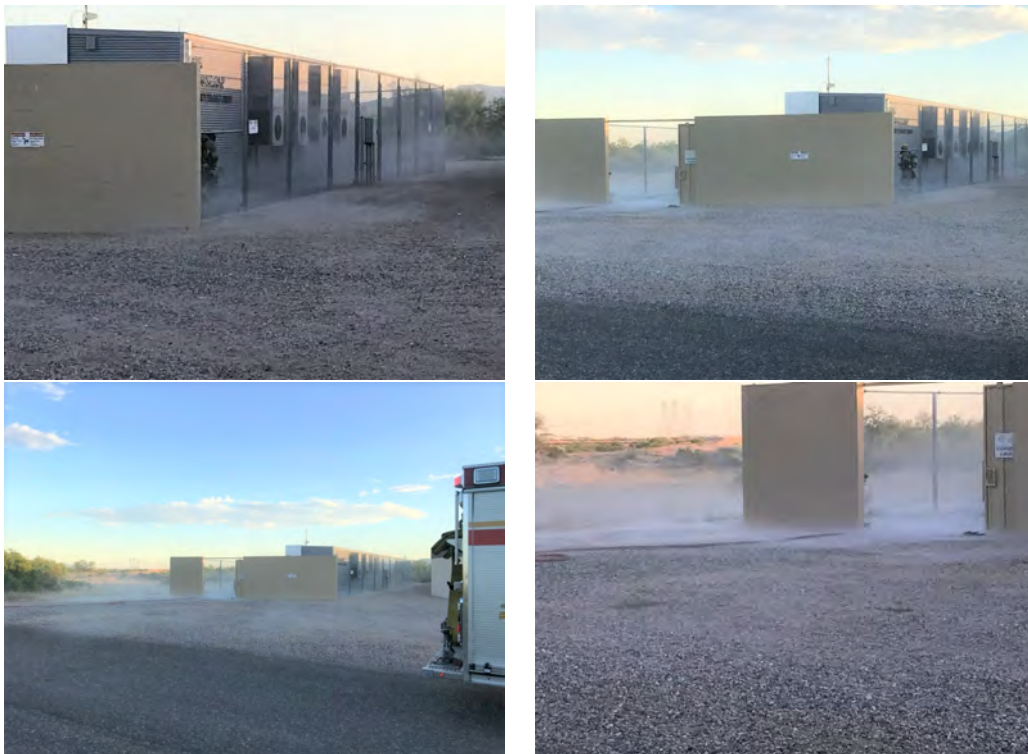
Figure 4.9: Photographs of the ESS scene taken by E193 FE upon the arrival of E193 [6].

Figure 4.9 indicates the ESS was actively leaking gases and vapors when the HAZMAT team arrived and performed a size-up approximately 100 minutes after the Novec 1230 was discharged. Based on a conservative estimate of the apparent area and depth of the vapor cloud in the photographs (100 ft x 60 ft, and a depth of 3 ft), as well as the estimated internal volume of the ESS, a volume of gas/vapor mixture sufficient for at least two complete volume changes had likely occurred. The continual leakage of a mixture of air, gases and vapors produced during thermal runaway, and Novec 1230 over time caused the concentration of the clean agent to fall below the design concentration. It is unlikely the concentration of Novec 1230 remaining in the ESS at the time the door was opened provided meaningful protection against the ignition of flammable gases and vapors that had accumulated in the ESS.

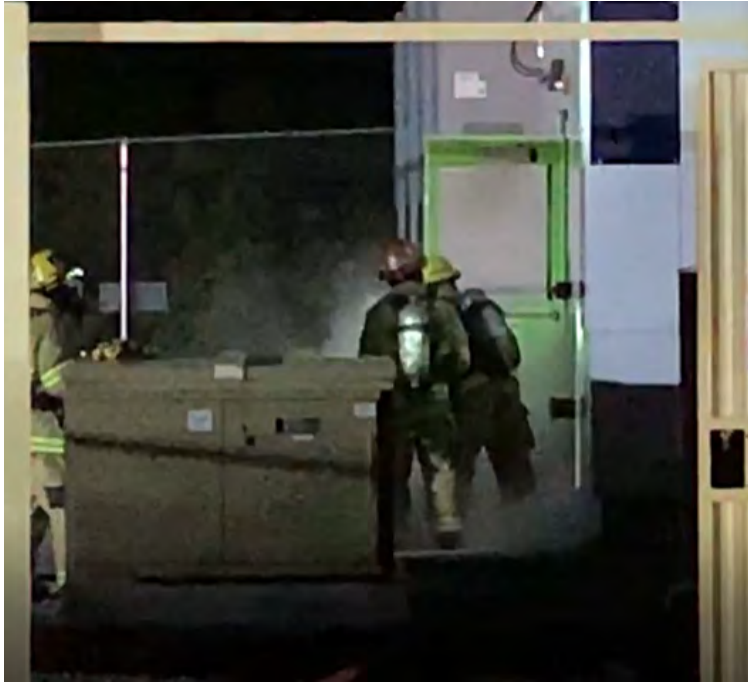
the container with the TIC. A visible white gas/vapor mixture immediately poured out of the open door while the HAZMAT team measured gas concentrations and continued to monitor the ESS. Images extracted from a video recorded on the scene as the door was opened are displayed here. Figure 4.11 displays E193 Capt (red helmet) and E193 FE (yellow helmet) just prior to E193 FE opening the door to the ESS. The hoseline that the HAZMAT team had brought into the hot zone in preparation of opening the door can be seen at the bottom of the image at the entrance gate. Figure 4.12 displays E193 Capt, E193 FE, and HM193 FF1 (far left of image) approximately 5 s after the door was opened. Dense gases and vapors can be seen in the image in Figure 4.12 flowing out of the ESS through the door.

Figure 4.12: Image of the HAZMAT team 5 s after opening the door [14].

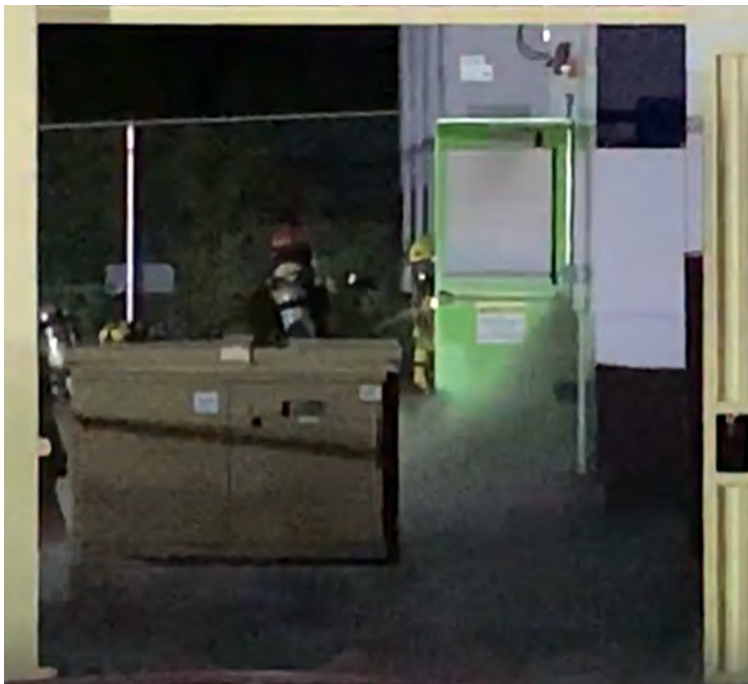
Figure 4.13 displays E193 Capt, E193 FE, and HM193 FF1 approximately 22 s after the door was opened. E193 Capt is shown using a TIC to monitor temperatures inside the ESS. Apparent in the image is an increased flow of high-density gases and vapors out the door as well as increased coverage of the ground in the vicinity of the ESS by the gas/vapor mixture. Figure 4.14 shows E193 FE holding the door open and E193 stepping away from the ESS to retrieve a gas meter approximately 33 s after the door was opened. The high-density gas/vapor mixture can be seen flowing from the door from high elevation to low elevation.

Figure 4.13: Image of HAZMAT team 22 s after opening the door [14].

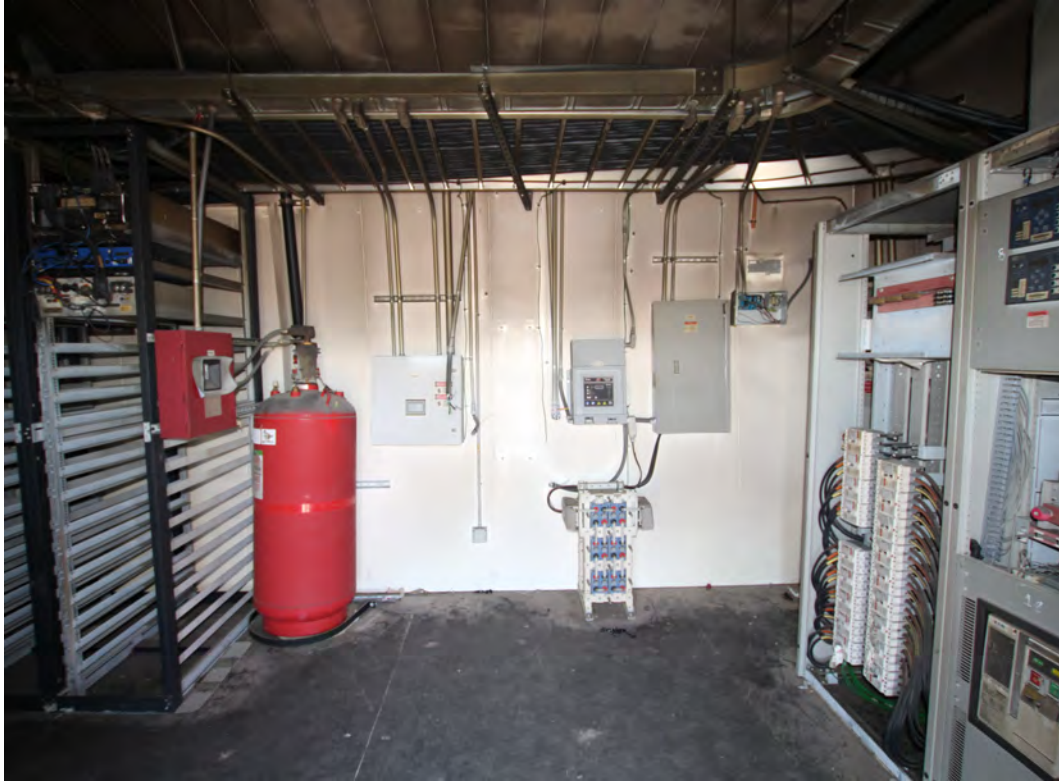
Figure 4.15: Photograph of view into the ESS from the entry door [13].

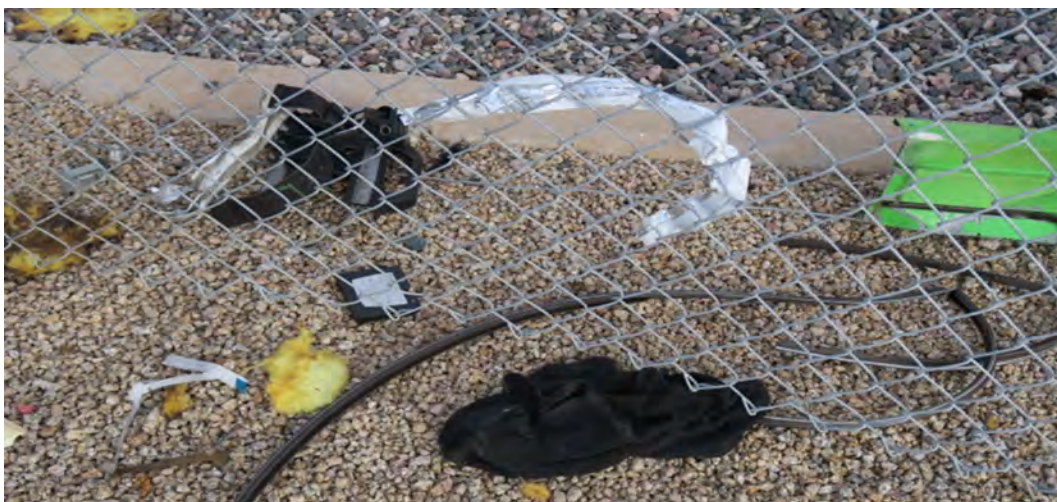
Figure 4.17: Photograph of firefighter equipment removed by the fence during the deflagration [6].

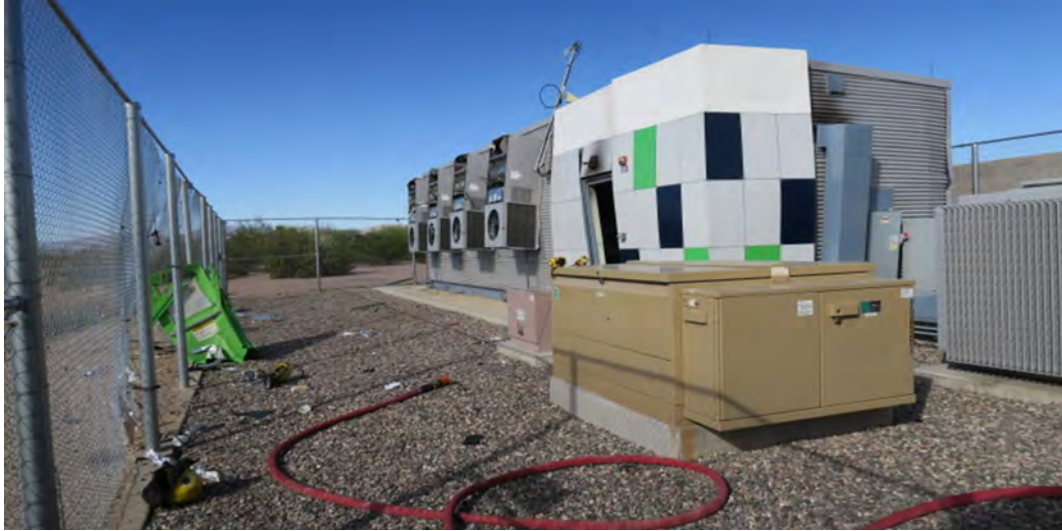
Figure 4.18: Photograph of firefighter helmets and the door to ESS removed during the deflagration [6].

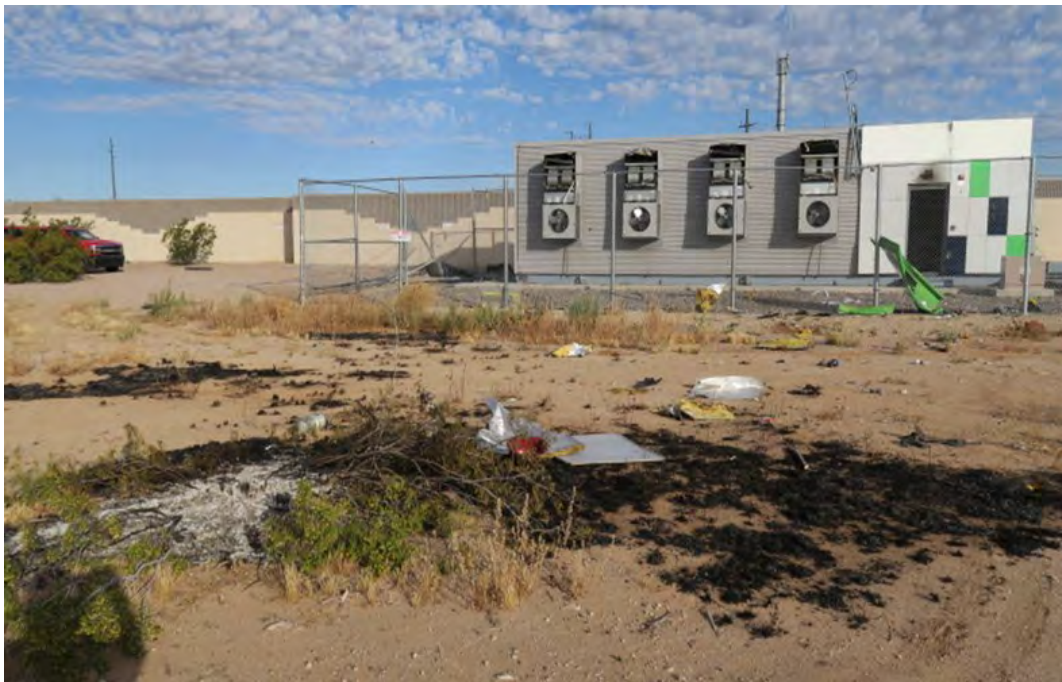
Figure 4.19: Photograph of burned bush, E193 Capt's helmet, and SCBA tank removed during the deflagration [6].

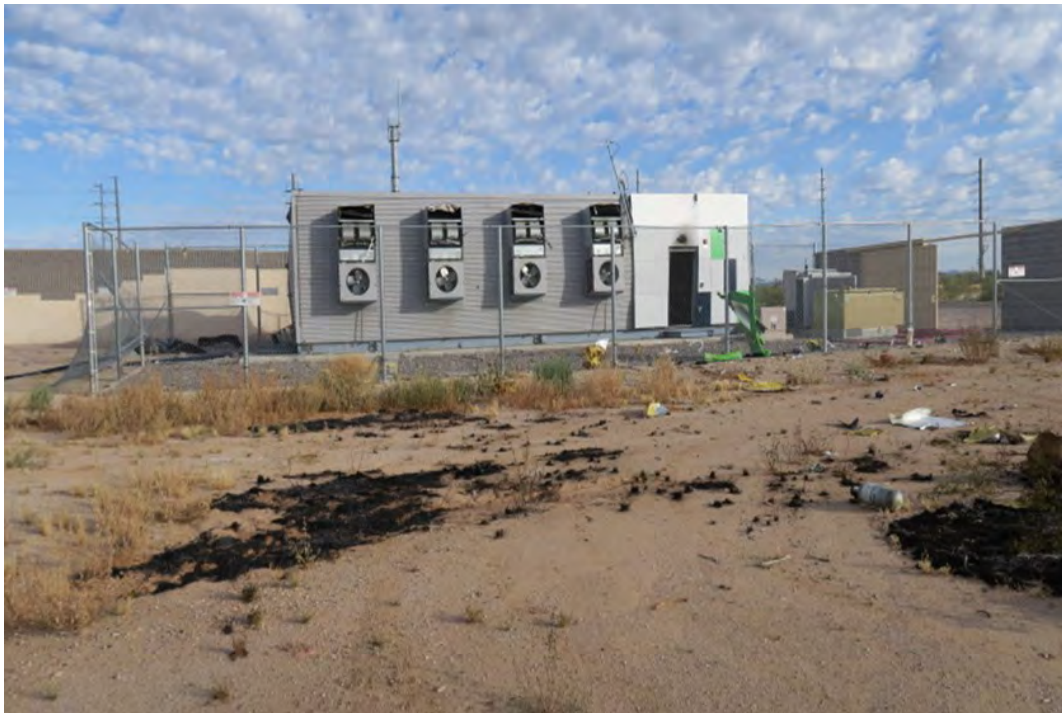
Figure 4.20: Photograph of fire debris and SCBA tank removed during the deflagration [6].

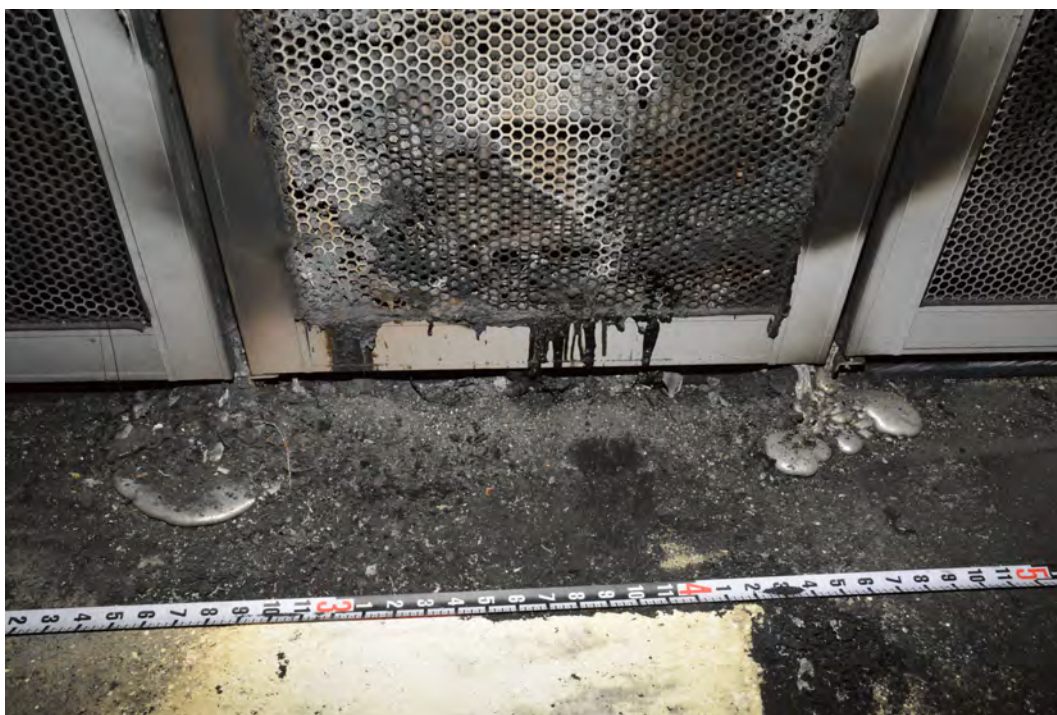
A photograph of the floor in front of Rack 15 taken during decommissioning is provided in Figure A.1. The photograph shows solidified pools of molten aluminum that apparently flowed down along the sides of the front of the rack during the incident. The melting temperature of aluminum is 1,220°F [22]. Studies conducted by the American Petroleum Institute suggest that a surface temperature approximately 360°F above the autoignition temperature is required to facilitate ignition [36]. Hydrogen as well as most hydrocarbons, which are major components of the gas mixture expected to be released from lithium-ion batteries undergoing thermal runaway, have autoignition temperatures below 860°F [37]. It has also been observed that the exothermic reactions that are a key contributor to propagation of the thermal runaway process produce temperatures that are capable of causing hot surface ignition of flammable mixtures [22].

Figure A.1: Photograph taken during decommissioning of the ESS shows a pool of solidified aluminum on the floor in front of Rack 15 [11].
