Four Firefighters Injured In Lithium-Ion Battery Energy Storage System Explosion - Arizona

Mark B. McKinnon
Sean DeCrane
Stephen Kerber

UL Firefighter Safety Research Institute
Columbia, MD 20145

July 28, 2020

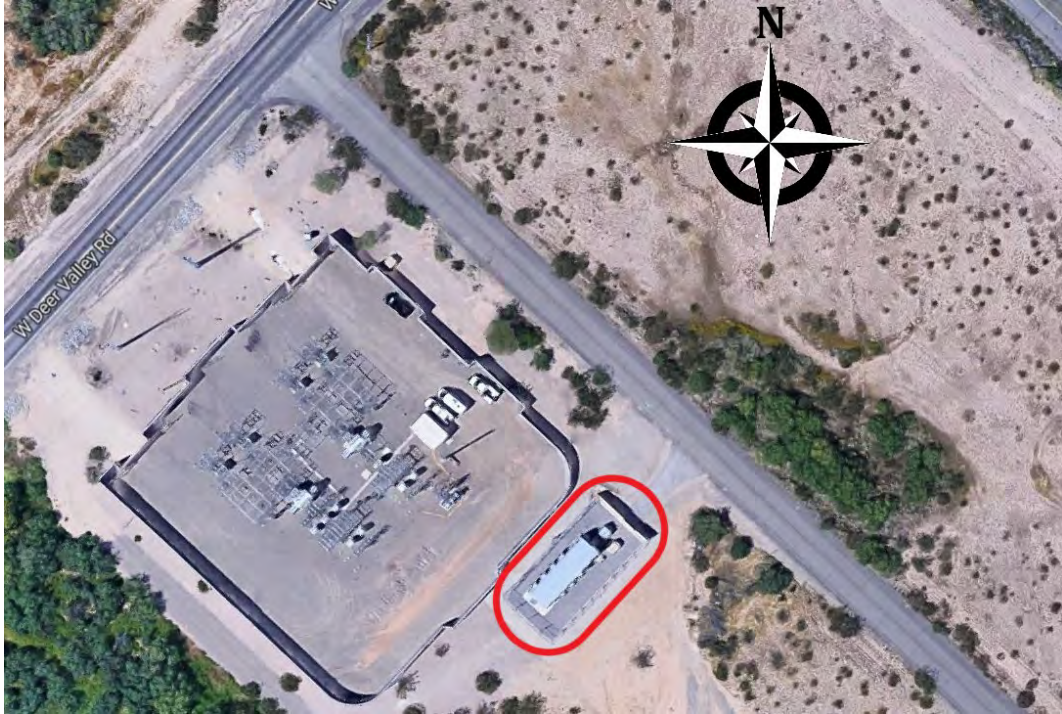
The lithium-ion battery ESS was housed within a steel structure with approximate exterior dimensions 50 ft x 14.25 ft x 13 ft. An aerial image of the building site is provided in Figure 4.1, with the facility highlighted with a red outline. The building was oriented such that the side with the longer dimension ran from the southwest to the northeast. The structure had a steel door on the northeast side of the southeast-facing wall as well as a steel door in the center of the southwest-facing wall. These steel doors included transparent vision panels that allowed optical access to the interior of the building. The interior of the building was lined with insulation of unknown material and thickness [11]. The installation was put into service in March 2017. The building fire code at the time of construction was IFC 2012. This version of the fire code did not dictate specific thermal runaway management or ventilation for lithium-ion battery ESS, but set forth requirements for signage, seismic protection, and smoke detection. Note that the date the ESS was commissioned was prior to release of a first draft of the current consensus standard on ESS installations, NFPA 855 [1].

Figure 4.1: Aerial photo of lithium-ion battery ESS site with the facility outlined in red. (modified from [12])
